Manhole Inspection Summary

Manhole # S09WW1020MH

Location Address: **2707 MANHATTAN AVE**

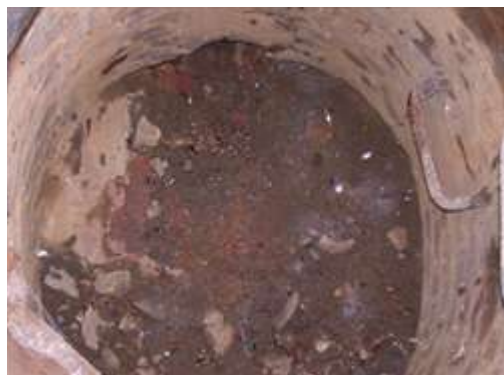
Top View

Corroded steps. Channel debris.

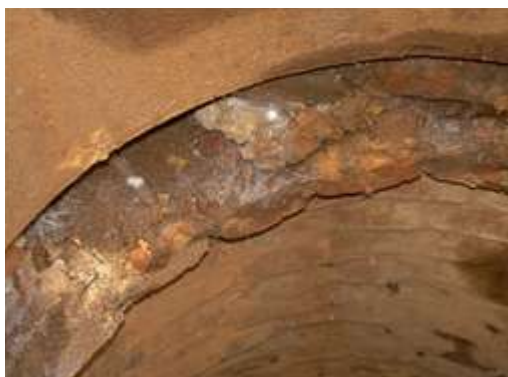
Defect

Frame leaks. Frame offset. Adjustment deterioration and infiltration. Barrel infiltration.

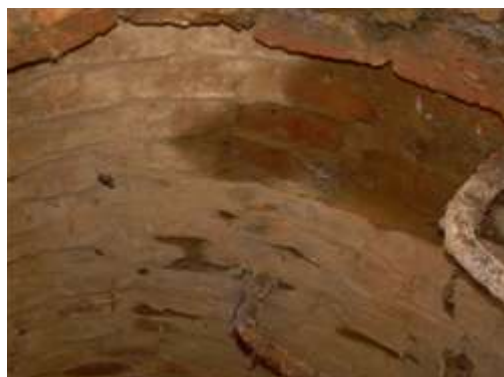
Defect

Adjustment deterioration, loose brick and infiltration. Corbel and Barrel infiltration.

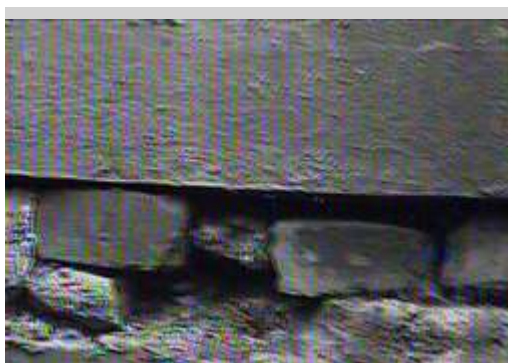
Defect

Frame leaks. Adjustment deterioration, loose brick and infiltration.

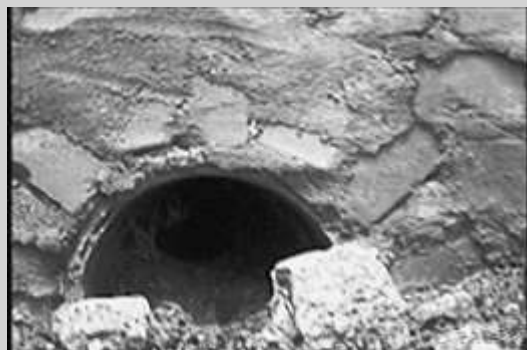
Pipe Out @ 12 O'Clock

Deposits: ☐ None ☒ **Mud** ☐ Sludge ☒ **Debris** ☐ Grease

Silt Depth: **2** (in.)

Infiltration: **Evidence**
